SAFETY RECALL

Mack Trucks Inc.
Greensboro, NC USA

Date	Number	Page
7.16	SC0403	1(12)

Interaxle Yoke Retaining Nut

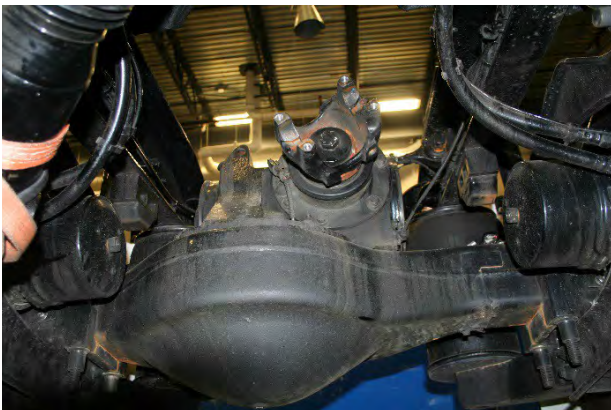
- i. Is the nut already loose?
 - a. Yes, proceed to step 8.2
 - b. No, proceed to step ii
- ii. Is the seal leaking?
 - a. Yes, proceed to step 8.2.
 - b. No, proceed to step 8.1

- iii. Is the yoke loose?
 - a. Yes, proceed to step 8.2.
 - b. No, proceed to step 8.1

8. Perform the following inspections:

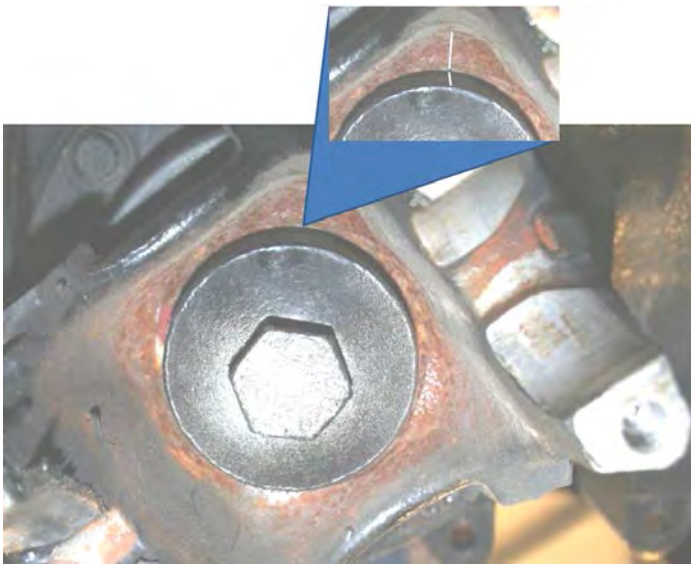
Figure 1

- i. Scribe a line on the nut and a corresponding line on yoke that meet where the nut contacts the yoke (figure 1).

- ii. Check for a breakaway torque by applying 2440 Nm (1800 lb-ft) to the nut in the counter-clockwise direction.
- iii. Verify the nut did not move by observing the alignment of the scribed lines on the nut and yoke
- iv. If the marks are no longer aligned, continue to remove the nut and proceed to step 8.2.
- v. If the alignment remains, nut replacement is not required, proceed to step 22.

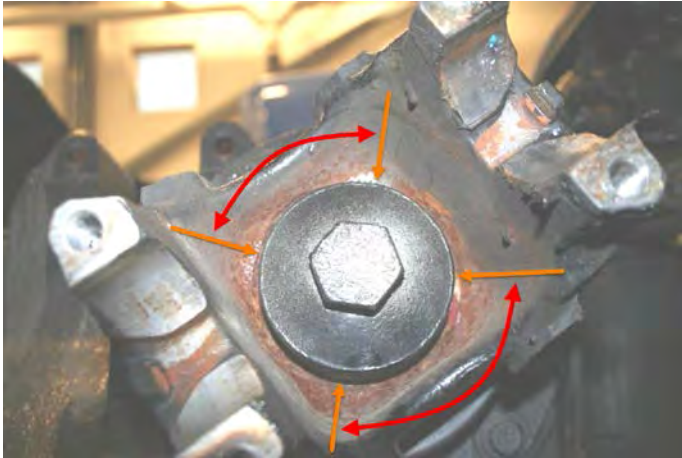
Figure 2

- i. Use a torch to heat the nut in two locations, 180 degrees apart (between the orange arrows in figure 2) to break down the thread locker.
- ii. Immediately remove the nut using a 1" drive impact wrench.

If heat is used to remove the nut, it is mandatory that the seal is replaced.
